Temporary Roads

Landscape Vegetation Analysis
Supplemental Information on Temporary Road Water Resources Effects

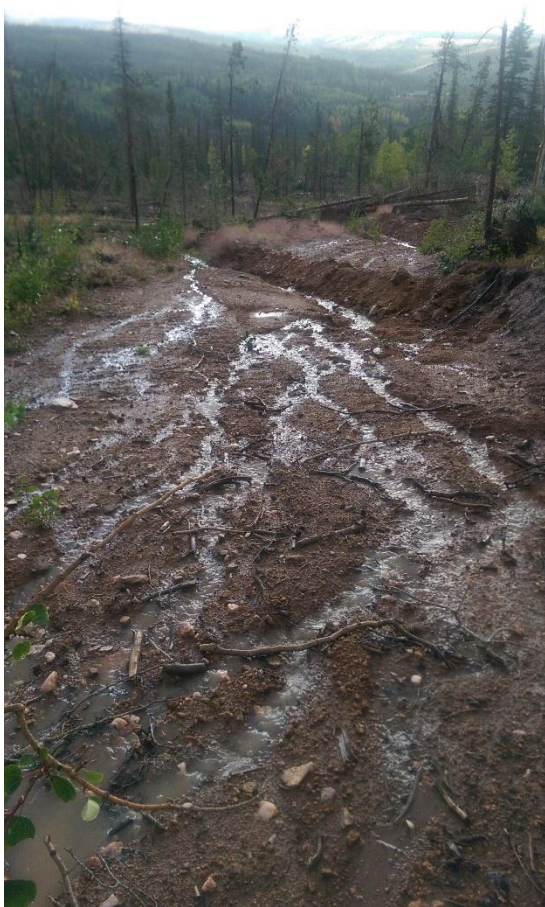
Figure 1. Soldier Summit Timber Sale Road (Sierra Madre Range) which was blocked at the entrance and water barred after sale activities were completed. Monitoring observations approximately one year later (September 15, 2017), revealed runoff and erosion during a moderate rainfall event. The objective of design criteria in the LaVA project are to provide more complete obliteration that will result in less runoff and erosion and shorten the length of time with adverse water resource impacts.

Temporary roads are typically in service for 1-4 years, then obliterated within 3 years (Timing PDF #1), with 1-5 years for ground cover to effectively reduce erosion and runoff to pre-disturbance conditions (see Figures 1, 4 & 5). Many individual temporary roads *at the site-scale* are likely to have short-term sediment effects, being constructed, used and obliterated within one or two operating seasons, with effective ground cover being established within a couple years. Per Watershed Conservation Practices Handbook definition of long-term effects being greater than 5 years, *at the watershed-scale* (e.g. a sale with multiple harvest units and several temporary roads being used for harvest over several years), *and in some cases at the site-scale* (e.g. an individual temporary road), overall temporary roads from the LaVA project *at the watershed scale* have long-term watershed condition effects. Evaluation of the short versus long term effects of temporary roads on stream health requires more detailed site-specific information, which will be addressed during project implementation. Appendix A, Decision Making Triggers for the LaVA Project, will be used to ensure long-term stream is maintained to meet Forest Plan Standards and State of Wyoming designated uses for surface waters.

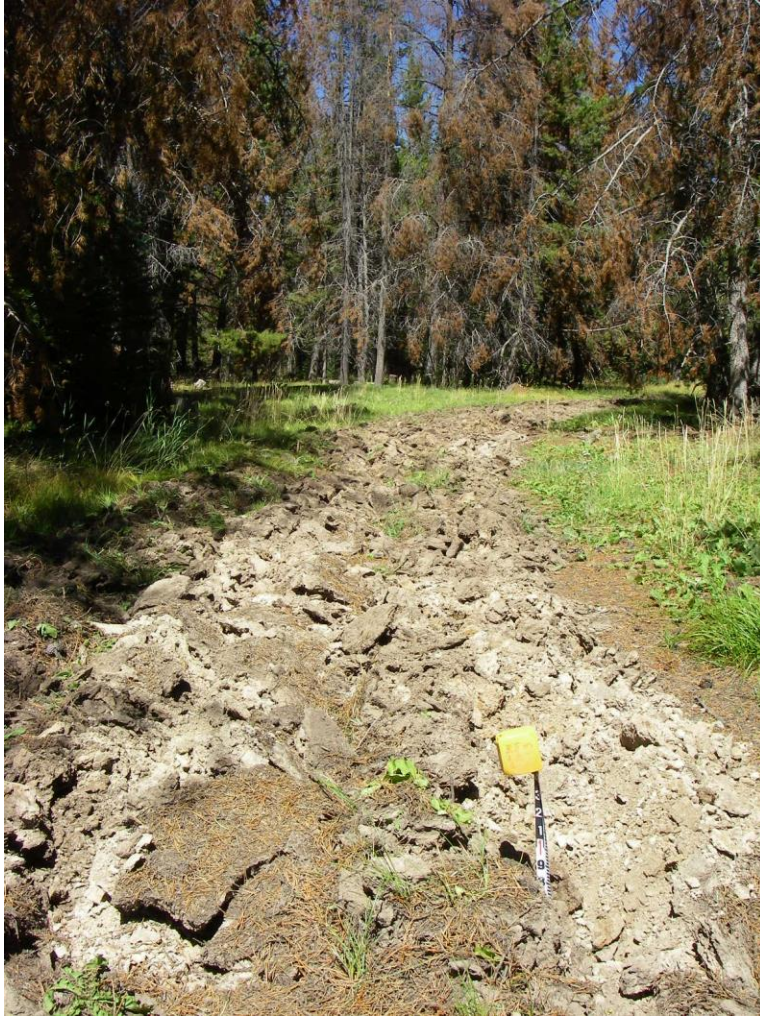
Figure 2. Example of road which was obliterated by scarification or ripping, similar to North Savery Design Criteria, Compaction #1.

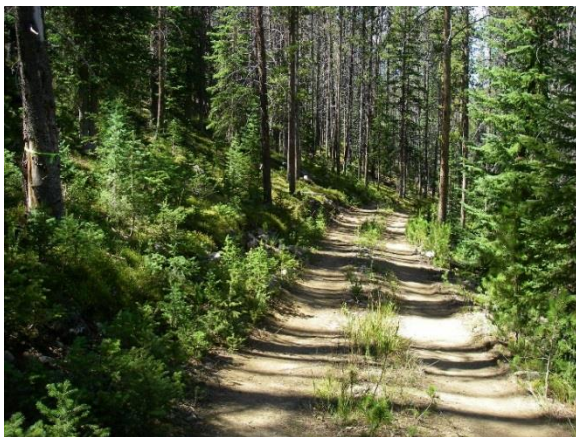
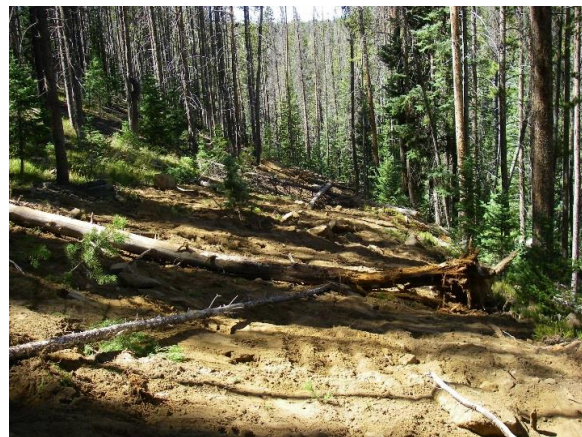
Cut/fill road before recontouring

After recontouring

Figure 3. Example of road which was obliterated by full recontouring, similar to LaVA Design Criteria, Erosion Control #1.

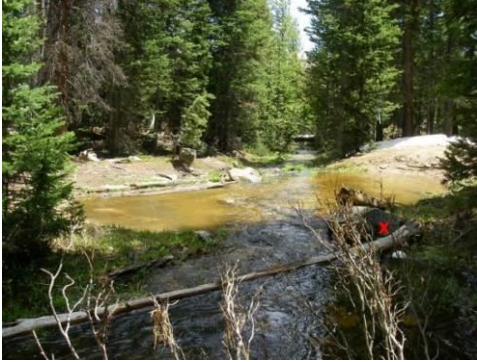
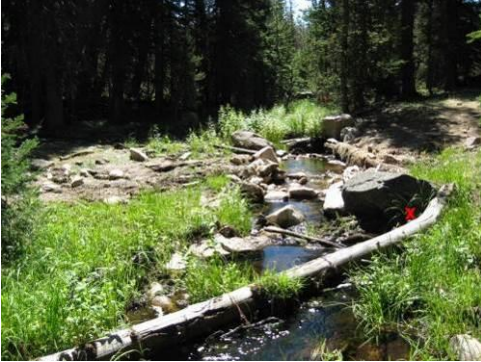
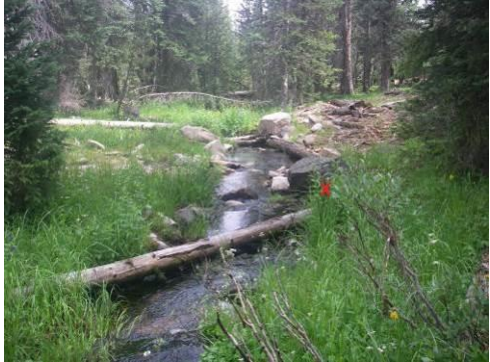
Route 561.02—Stream Crossing Restoration Example

Before decommissioning--2009	One year after decommissioning--2010	Six years after decommissioning--2015
Route 580.07—Stream Crossing Restoration Example

Figure 4. Examples of reducing erosion and sedimentation and restoration of stream channel and riparian areas through decommissioning road crossings. Snowy Range Mountains, Douglas Creek drainage.

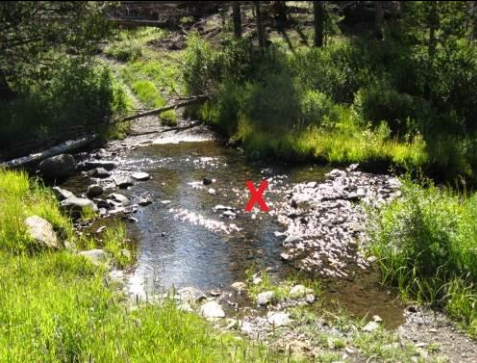
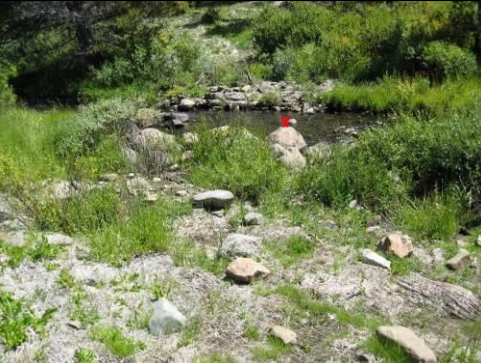
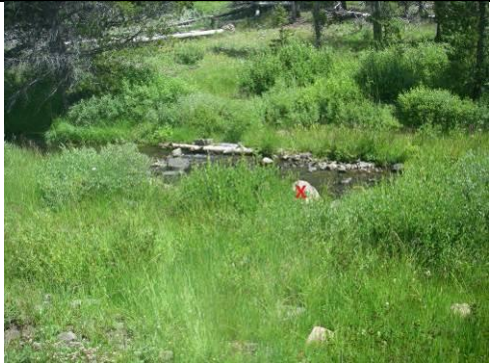
Before decommissioning--2009	One year after decommissioning--2010	Six years after decommissioning--2015

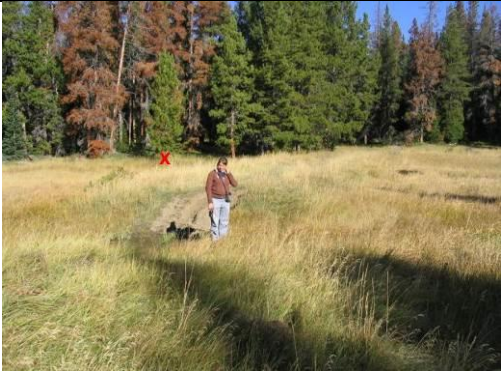
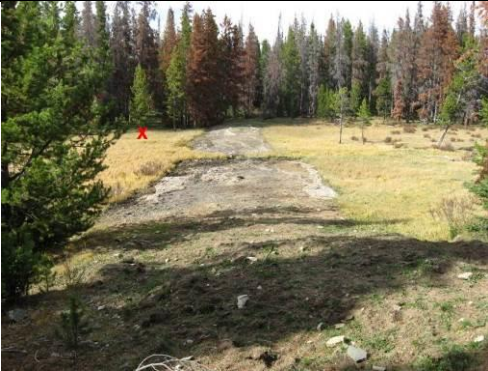
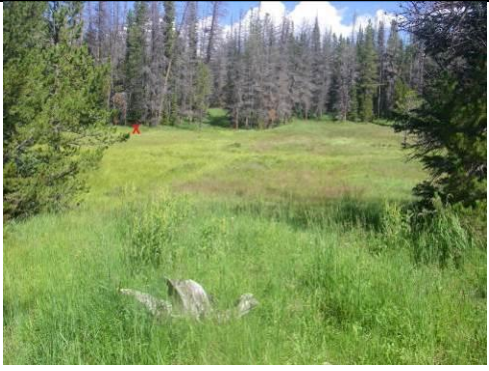
Route 524.03—Wetland Restoration Example

Before decommissioning--2008	One year after decommissioning--2009	Seven years after decommissioning--2015
Route 526.I.02—Wetland Restoration Example

Figure 5. Examples of restoration of riparian area and wetlands through decommissioning road crossings. Snowy Range Mountains, Douglas and Boswell Creek drainages.

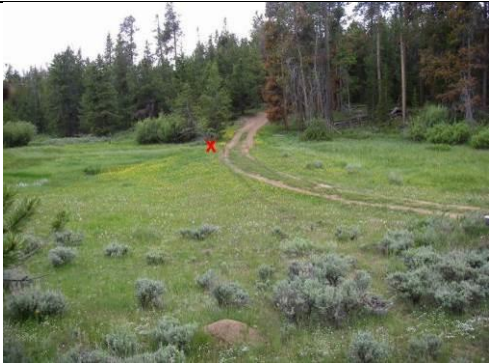
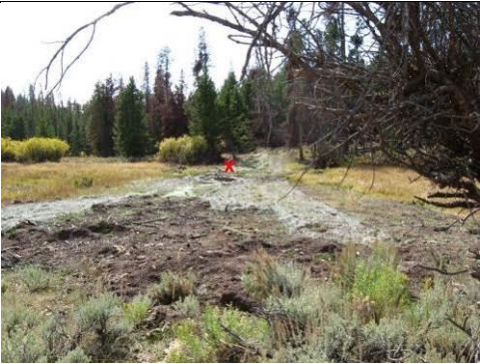
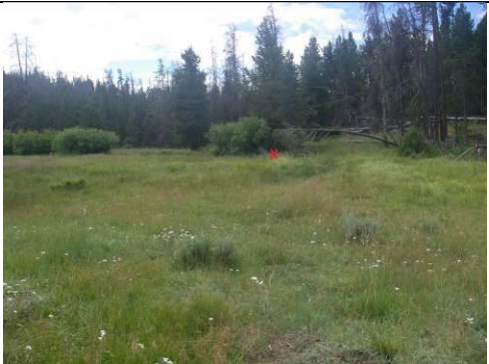
Before decommissioning--2008	One year after decommissioning--2009	Seven years after decommissioning--2015
